An integrated study of a gearbox failure

Dalia El- Gazzar

Mechanical & Electrical Research Institute, National Water Research Centre,
Ministry of Water Resources & irrigation, Delta Barrage, Egypt
dalia_engdalia@yahoo.com

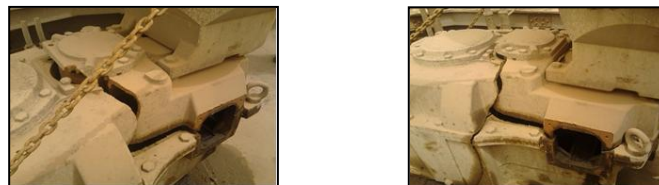
The gearbox was disassembled and inspected for all internal components, both failed and undamaged. Visual inspection is a certain procedures to indicate installation and configuration factors that related to gear failure such as, oil leakage and loose hardware. The main goal of visual inspection is to investigate and check all parts of the gearbox as much as possible. The visual inspection concentrates on potential mechanical and environmental effect on the gearbox failure. The damaged components of the broken gearbox were visually inspected. The gearbox top cover casing is totally broken as shown in Fig1.

Fig1. Gear box top cover casing is broken into two parts.

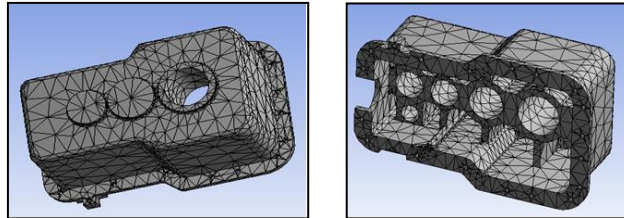
Fig8. Finite element model.

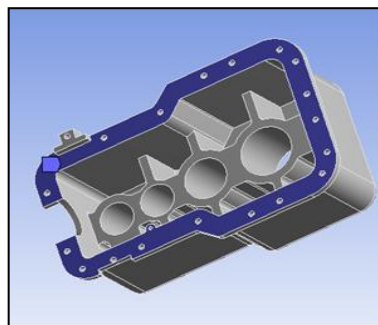
Fig9. Fixed support of gearbox casing.

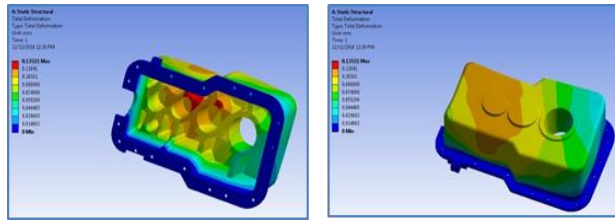
Bearing pressure is applied to the bearings locations in the gearbox. The total load acting on the casing is also applied. Deformation occurs in gear box casing is shown in Fig. 10. Von- Mises stresses occurred on gearbox casing are shown in Fig. 11. Validation established by comparing the results of the simulation with the actual data that was founded indeed. The results show that the deformation of the gear box casing is found to be maximum at the same place that the actual failure happened. The Von Misses stress or equivalent stress was found to be maximum in a region where the gears attached to the bearing, this region where the failure occurred. Verifying the model established by comparing the maximum Von Misses stress (184.74 Mpa) with the actual yield stress of the cast iron (170 Mpa). It could be seen that the Von Misses stress exceed the yield stress of the industrial material of the gearbox casing. This is verifying the main theory of the failure occurrence.

Fig10. Deformation occurs in gear box casing.

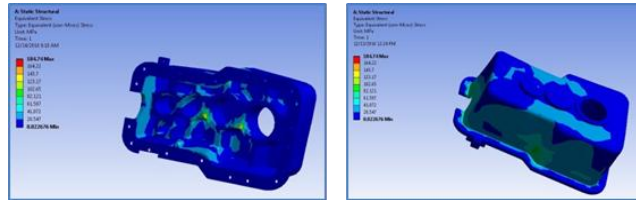
Fig11. Von- Misses stresses occur on gearbox casing.
